Modifications to the Terratrip Professional Intercom Amplifier to Eliminate Alternator Whine.

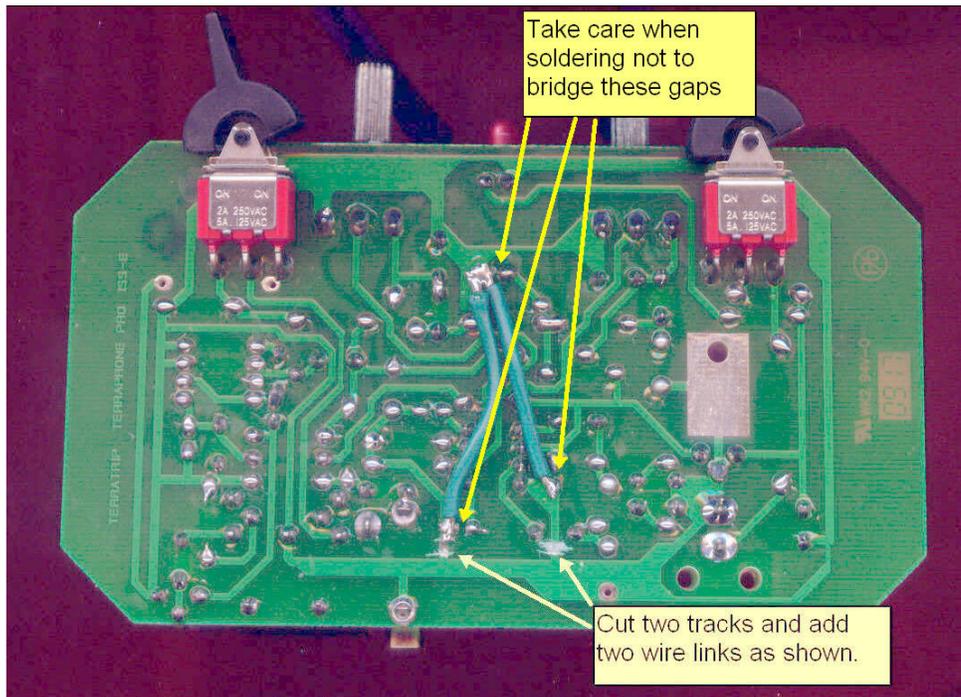
Due to the layout of the pc board, there is a long ground track that runs around the board and, because of the way that components are connected, it allows a noise voltage to be induced between the differential inputs. Because the alternator output carries a noise component, this noisy current flows through this track on the board and manifests itself as a whine on the output.

Refer to the accompanying photograph to see where to cut the two tracks and solder the two wire links. They should be insulated wires to avoid shorting out any other connections.

The tracks can be very carefully cut, preferably with a sharp scalpel or small Stanley knife. Make two cuts, approximately 3mm apart, across and through the copper strip. Then, gently lift one edge of the small piece of track to be removed with your knife and peel off, possibly aided by a pair of small tweezers. Make sure that you have cut right through the track, but no further, and take care not to lift or damage the remaining tracks. Repeat for the second track.

Once the tracks portions have been removed, make sure there are no bits of cut track floating around the board and then prepare the two wire links and solder them in place. Take care only to apply sufficient heat to solder the wires in place as too much will cause the tracks to lift from the board or may damage other components.
